Resin Bound Cracking

Prevention

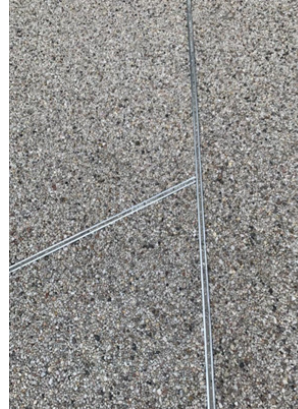
Example of joints needed.

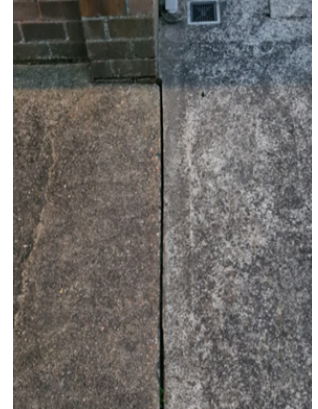
Example of 2 different substrates which would require a join.

Examples would be adjoining a tarmacadam base with a concrete base or extending a concrete base with a cellular grid base. Differing substrates can also mean their curing profile - where both are concrete, but a new slab is laid next to an existing aged slab. Different substrates will behave differently when curing, reacting to a load being exerted on them and thermal change. These changes create movement, which creates tension and subsequently cracks can appear in the resin bound surface.

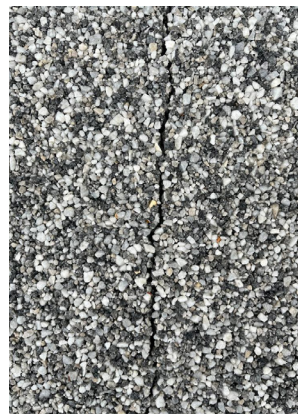
Example of cracking in resin bound.

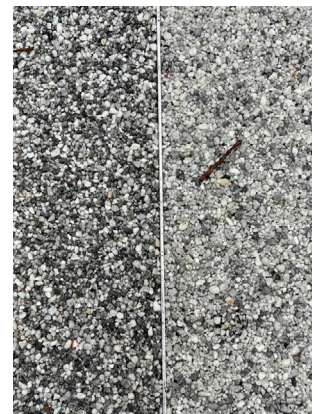
Movement joint with applied resin bound surface.

For joints believed to be too large to repair, or if they are of a structural nature and so their movement is needed as part of the structure of the base, an expansion joint can be installed. You can see (right) an example of an expansion joint which is set in place over the location of the joint, and the resin bound surface is applied up to.
